REHABILITATION OF 100 YEAR OLD STORM WATER CULVERTS

By Datta Shirodkar, P.E. and Michael Spero, P.E.

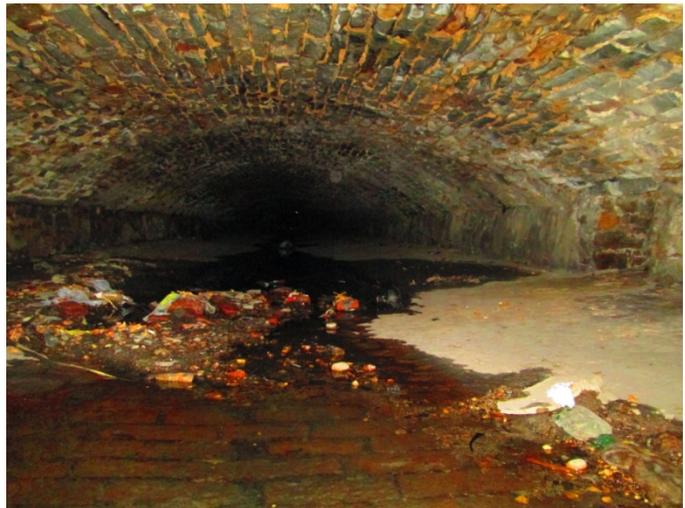
Central Avenue in Baltimore, Maryland is a major artery that has 4 driving lanes, 2 parking lanes and a 20 foot wide median for most of the project length. Under the median, in the center of the street, is a storm drain that is over 100 years old. For this project about half the pipe length is brick and the remainder is cobblestone. When built, Central Avenue, was a divided street with a canal in between carriageways. Originally it was named Canal Street. The canal became a drainage way and eventually replaced by the brick/stone storm drain and the area around the pipe filled in. The top of the culvert is only 2 to 6 feet below the road surface. At several locations where there is a cross street, the pipe had failed and was previously repaired in the form of timber or steel struts. Some of these median crossings were barricaded to prevent traffic loads on the pipe. As part of the \$27 Million reconstruction of Central Avenue, the City of Baltimore decided to structurally rehabilitate the existing failing brick/stone culvert. The culvert consisted of 7 different sizes and shapes ranging from a 5 ft. high by 7.5 ft. wide oval to low arch pipes up to 6 ft. high by 16 ft. wide. The majority of the 3,275 linear feet of pipe rehabilitated was the latter (see Figure 1).

Figure 1 – Existing Storm Culvert

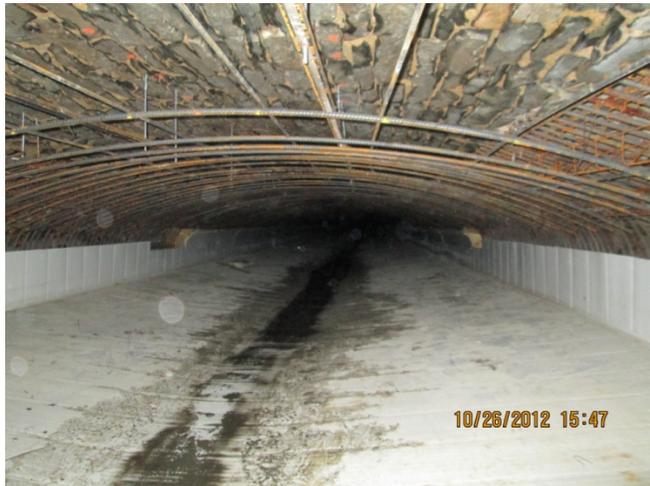
Figure 2-Reinforcing, Bottom & Side Panels

4. Steel slab bolsters were installed longitudinally in the bottom as spacers for the bottom PVC panels.
5. The bottom panels were installed, 90° PVC corner fittings attached, and the vertical side panels placed (see Figure 2).

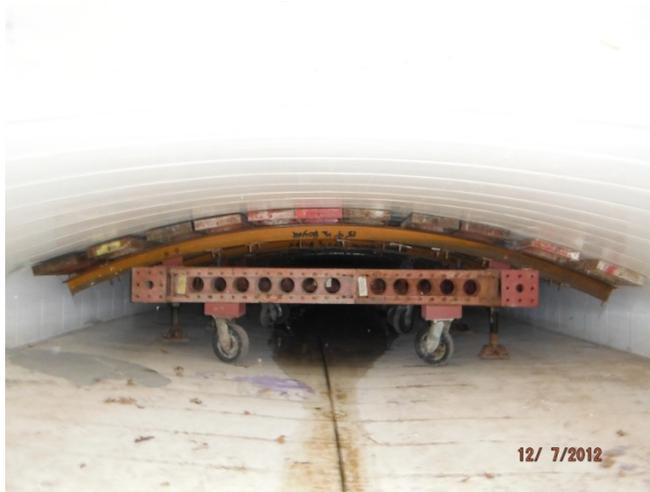
Figure 3-Top Panel and Moveable Bracing

12. Moveable bracing was placed to support the top panels (see Figure 3).
13. Top panels were grouted.
14. After the grout reached a strength of at least 2,000 PSI (about 24 hours), the bracing was moved to the next section (see Figure 4).

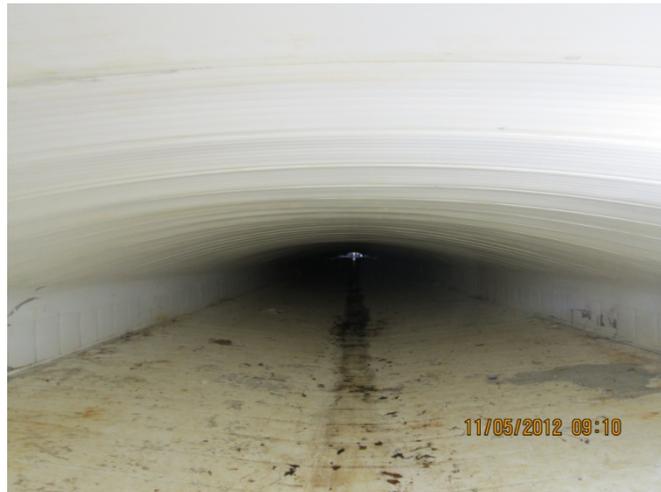
Figure 4-Completed Rehabilitation

The \$9 Million rehabilitation portion of the project was successfully completed in July 2013. The result is a storm culvert that will support the current and future traffic loads, has an increased hydraulic capacity in spite of the reduced cross-section due to the smooth liner surface, a corrosion resistant pipe that is sealed against infiltration and exfiltration and a part of the City's storm system that will be worry-free in the future. All the stakeholders; the Owner, design engineer and the construction manager were extremely pleased with the finished product and we anticipate that the rehabilitated storm drain will function for at least another 100 years.
