**UNDERGROUND CONSTRUCTION TECHNOLOGY
INTERNATIONAL CONFERENCE & EXHIBITION
JANUARY 19-21, 2010
TAMPA, FLORIDA**

REHAB OF 100 YEAR OLD BRICK STORM SEWER

Authors: Datta Shirodkar, P.E. – Project Manager– Boyer Inc.
Michael Spero, P.E. – President - Danby LLC

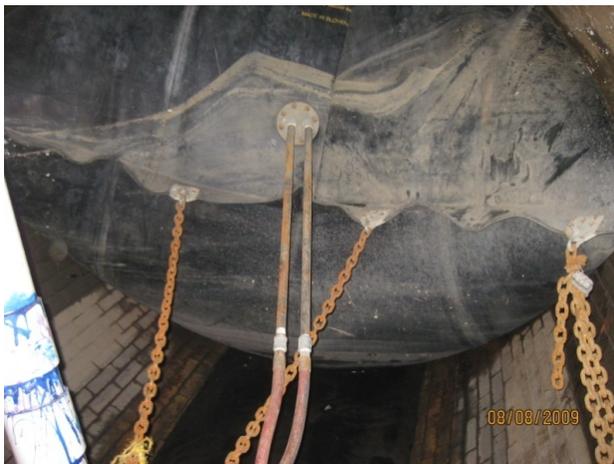
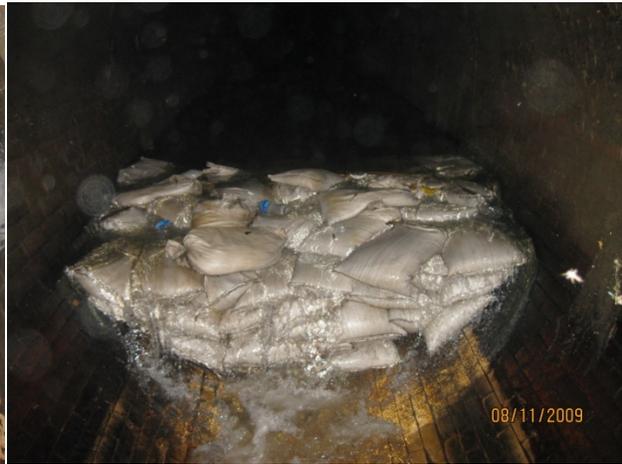
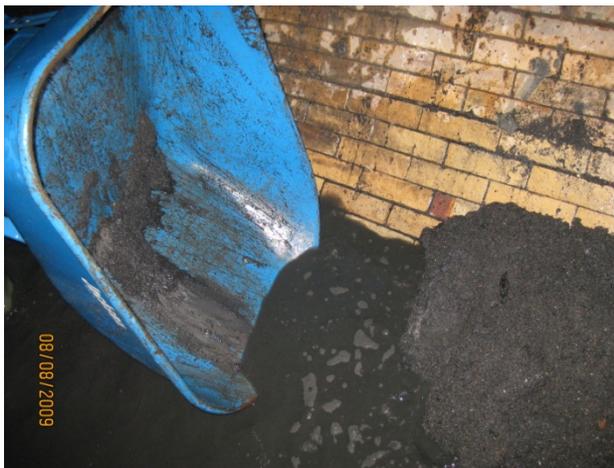
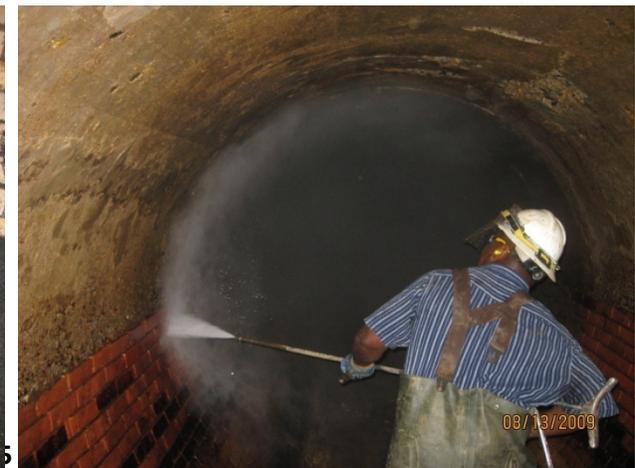
After the river backwater and pipe base flow were under control and the ventilation system established cleaning of the sewer was accomplished. The debris in the pipe was mostly sand and silt with an occasional brick or chunk of concrete dislodged during the installation of a lateral pipe. About half the debris was removed manually using wheel barrows. The remaining debris was removed using a jet rodder and vector truck. In preparation for the lining, the walls of the sewer were cleaning using a high pressure water blast of 6,000 psi. This removed any dirt, oil, grease, loose mortar, concrete, aggregates, laitance, or other contaminants. What remains is clean competent brick and concrete. There were 8 abandoned services and 1 groundwater leak that were plugged.

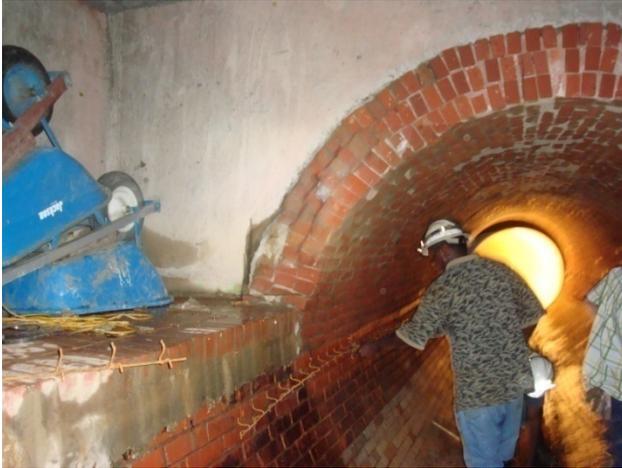
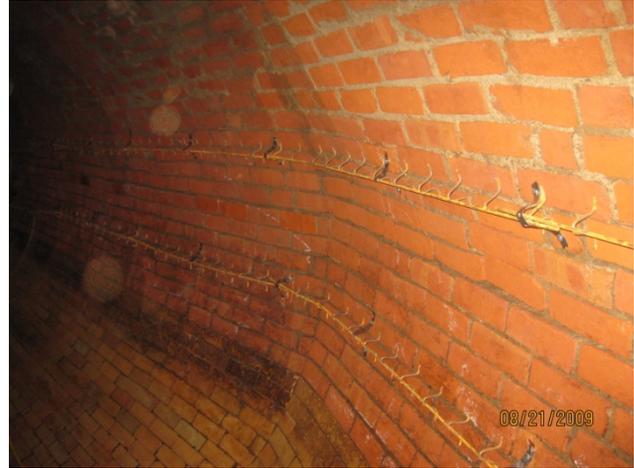
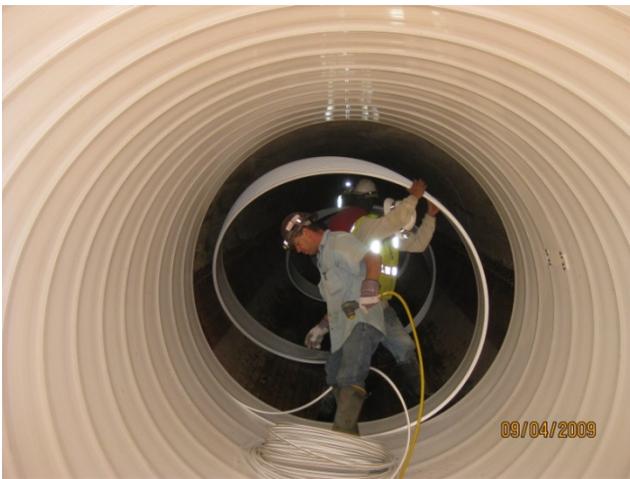
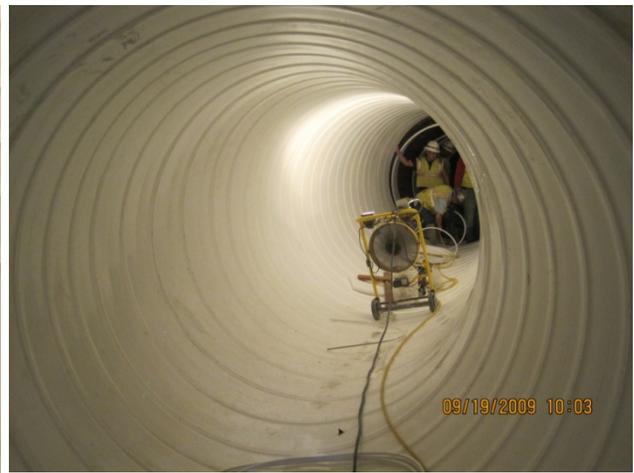
As can be seen in the drawings below the 3-inches of grout in the annular space will result in a liner ID of 84-inches. In order to maintain the 3 inch minimum grout thickness, steel spacers (bolsters) are mounted on the pipe wall. The 12-inch wide PVC panels come in 300 foot long coils. The liner is fed into the pipe through the manhole then pulled into position. The panels are spiral wound by connecting the adjacent panels with a Joiner Strip. The Joiner Strip is installed using a pneumatic Palm Hammer. The end of the next coil is connected to the previous one with an "H" Strip splice. A steel buoyancy restraint angle is anchored at the bottom of the liner. Grout bulkheads are placed about every 400 feet using hydraulic cement.

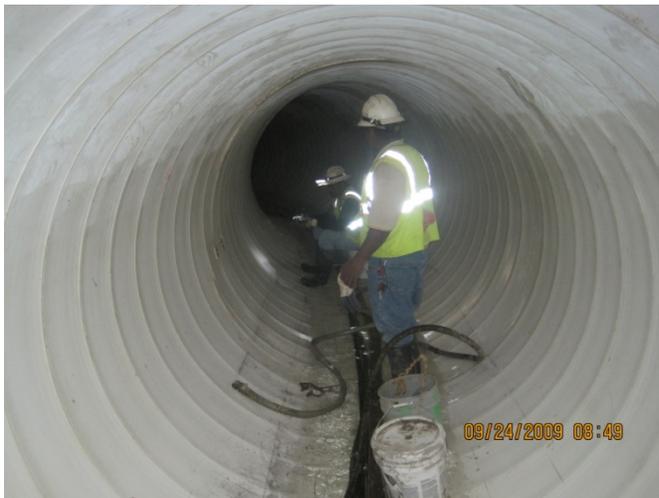
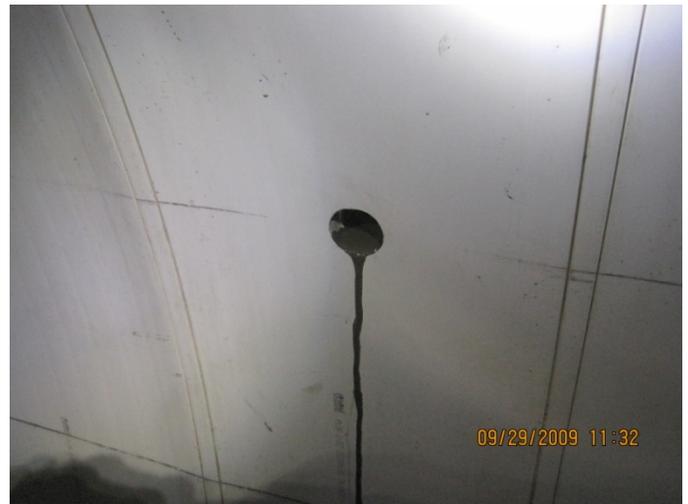
The liner is grouted in 8 lifts of about 12- inches each. Grout and vent holes are drilled in the liner about every 20 feet. The grout hose discharges into the grout hole and the mixture flows by gravity into the annular space between the liner panels and the host pipe. When grout starts flowing out of the vent hole, the hole is plugged and the hose is move to the next grout hole. The next grout lift is placed a minimum of 12 hours after the previous lift is completed.

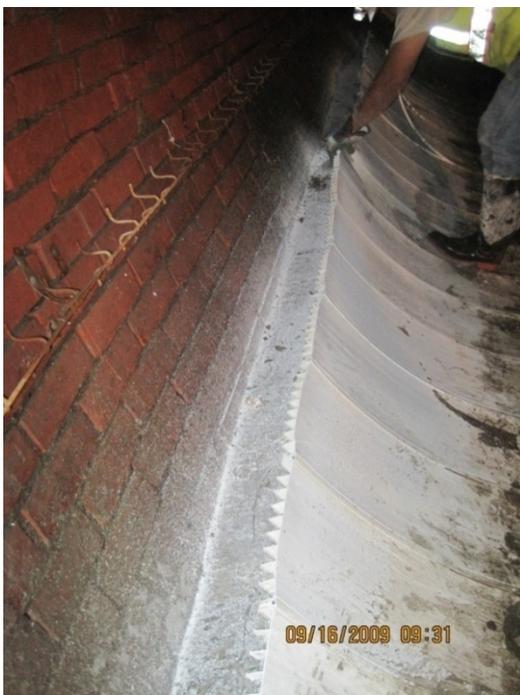
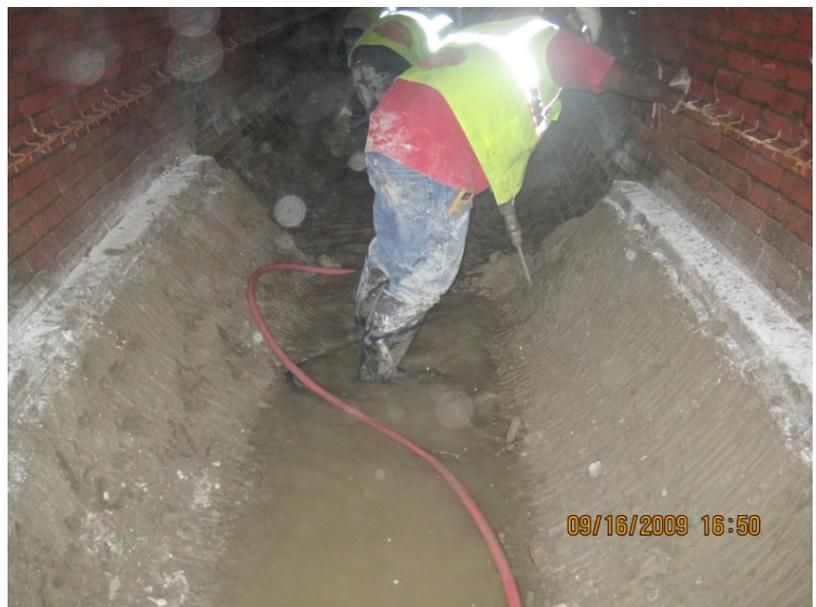
While grouting the 3rd Lift of the first section the liner buckled. The reason for this was the grout in the first and second lifts had not set, even after 36 and 12 hours respectively. This allowed the liquid grout in the upper lift to migrate downward where it exerted an excessive hydrostatic force on the lower sections of liner causing buckling. Because of the inadequacy of the grout and the buckled liner, Boyer decided to remove the liner and grout installed for the first 300 feet. Testing of the defective grout showed that it did not meet our required strength requirements. New liner was reinstalled for that section. Removing the liner and grout was a tedious process that entailed cutting out the liner and then removing the hardened grout in pieces using a jack hammer.

The primary issue with the cement/fly ash blend was the inconsistency of material and apparent deficiencies in the QA/QC at the supplier's plant. The initial mix supplier was given several opportunities to explain the reasons for the problems and correct the deficiencies. This was not accomplished to our satisfaction. We changed the supplier for the cement/fly ash blend and have not experienced any problems with grout quality since.
