Originally appeared in
Underground Infrastructure, July 2024.
Posted with permission.

REHAB TECHNOLOGY

Emergency Rehabilitation Brings Back Baltimore's Back River Outfall Interceptor

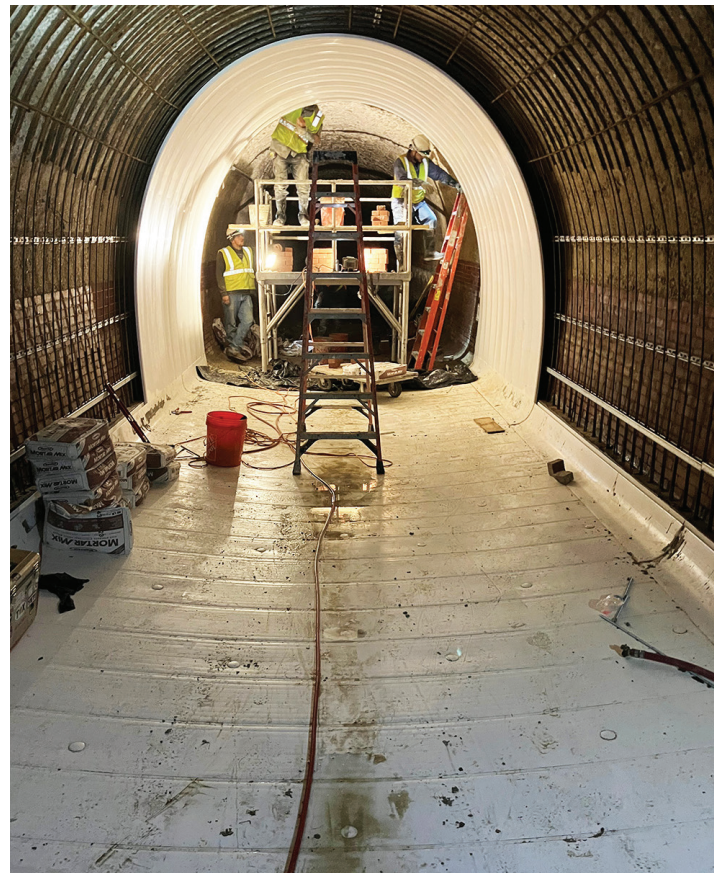
Composite solution, rebar and start of the Danby liner; grout was later installed in-between.

"We installed bolsters on the bottom floor and determined the proper annular space between the host pipe and the liner, which was later filled with high-strength cementitious grout," Grubbs.

"While the floor didn't require additional steel reinforcement (rebar), the sides and crown were designed with additional rebar to increase the interceptor's structural capacity and prevent cracking due to temperature changes," he added.

The grouting process was completed in two phases, first was the floor and curved corner. After the floor was grouted-in, the side and top rebar was installed, then the 25-foot-long top panels were grouted in 14 controlled lifts.

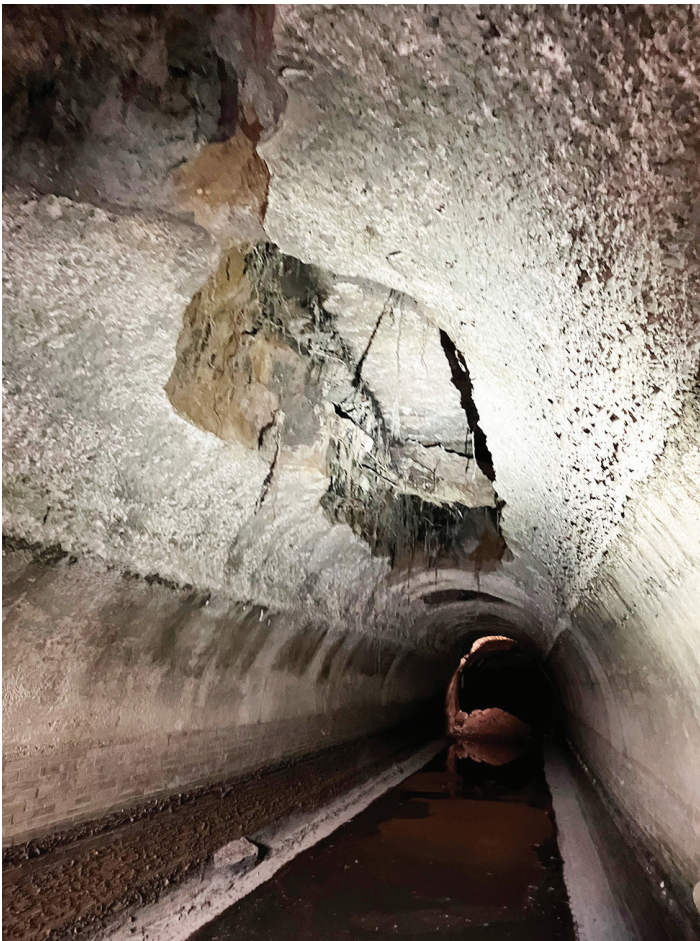
Before rehabilitation

"As soon as we could do a walkthrough, we saw the deterioration firsthand," said Cassel. "The damage to the crown was significant; not a surprise, but it certainly had a 'wow' factor."

CCTV and 3D laser (LiDAR) scans gave a more-accurate picture. "LiDAR revealed a crack approximately 56 linear feet long that was visible in the side and crown," said Walsh. "It also showed that the bottom two corners had failed and uncovered more-severe structural damage upstream."
