**STRUCTURAL STRENGTH OF DANBY PROCESS  
CONFIRMED BY D-LOAD TESTS**

# D-Load Tests of Lined and Unlined Deteriorated 24" RCP

At Rialto Concrete Pipe Company of Rialto, California

February 16, 1994

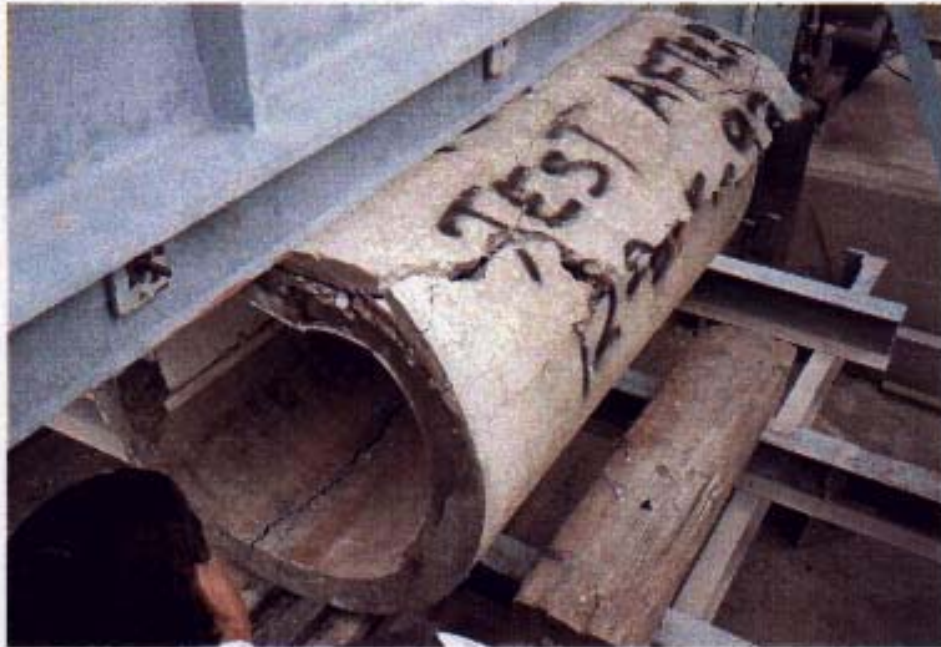
**TEST SUPERVISED BY  
COUNTY SANITATION DISTRICTS OF LOS ANGELES COUNTY**

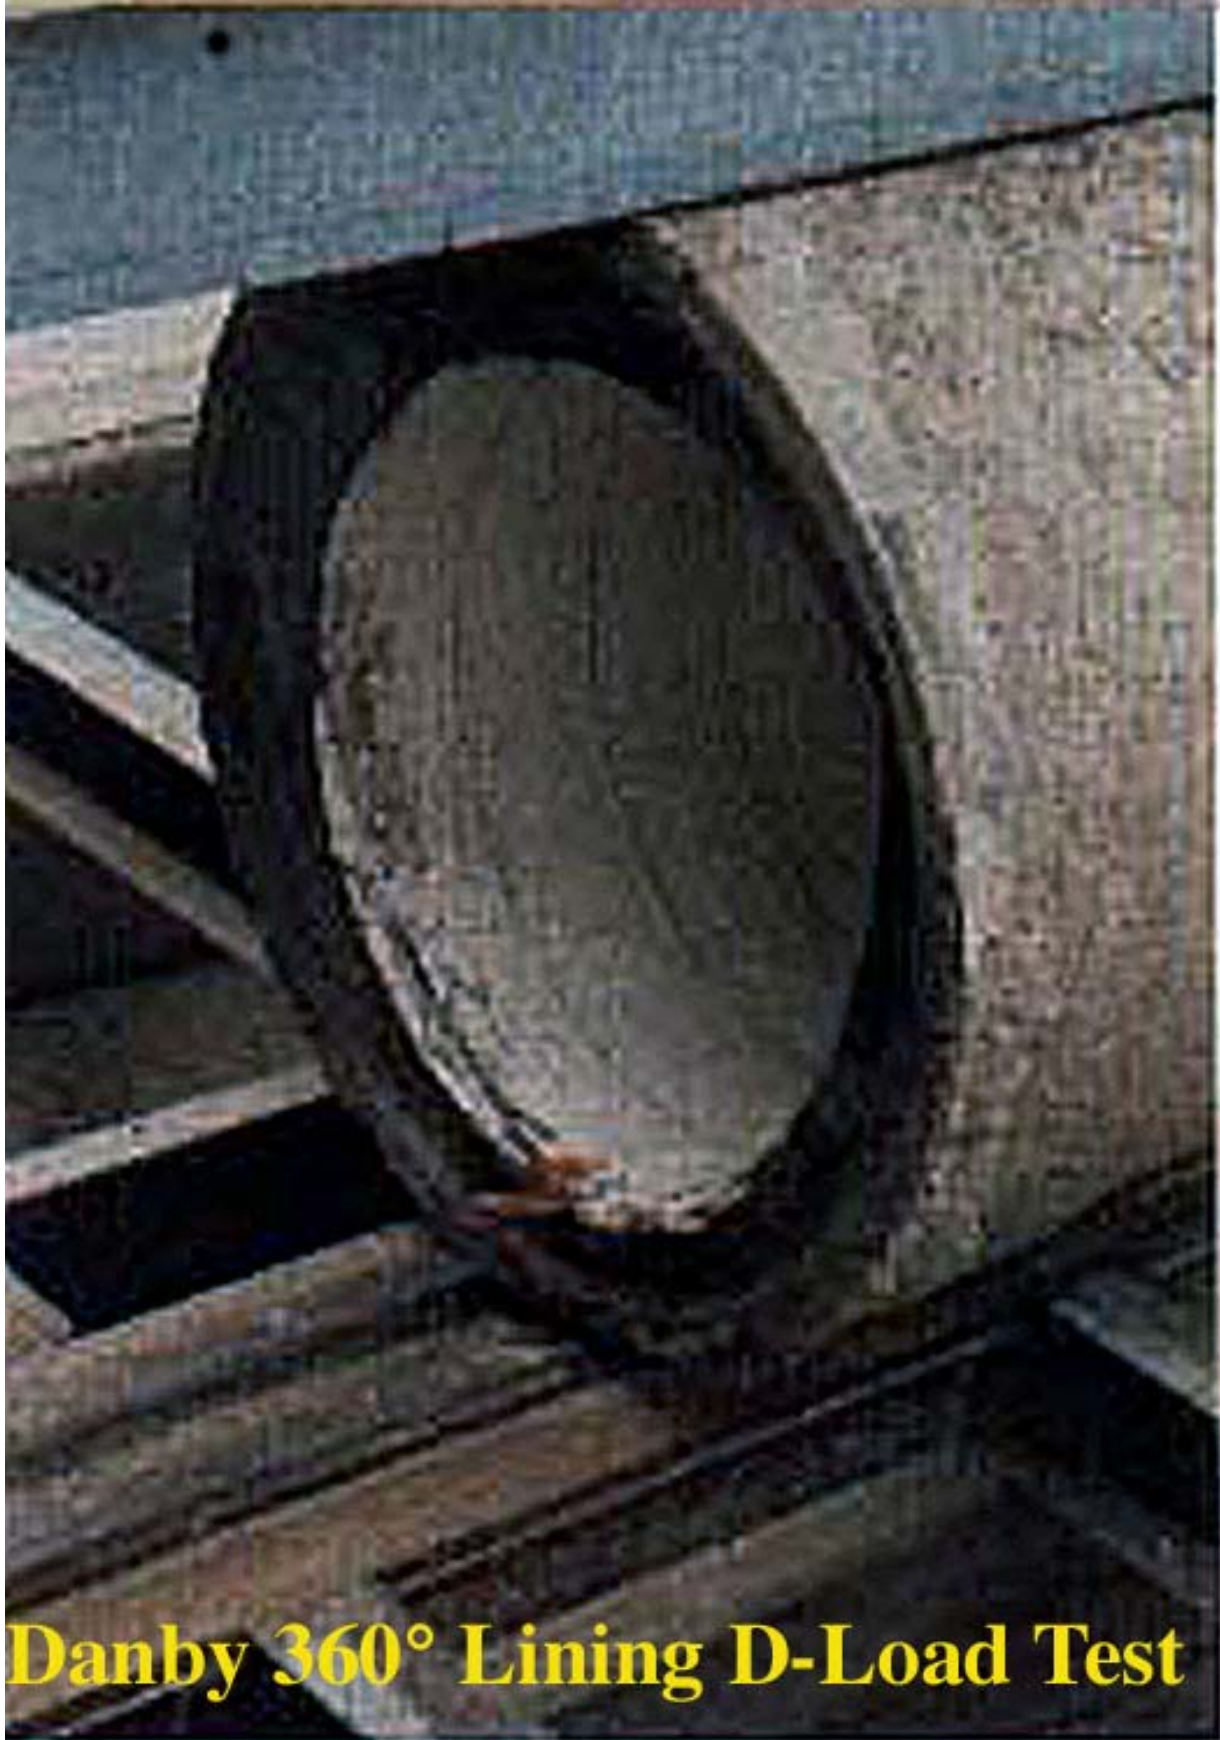
**Danby 360° Lining D-Load Test**

<u>D-Load</u>	<u>Unlined</u>	<u>Danby Lined</u>
		(270° lining)
First Crack	--	--
.01" Crack	2375	4563 (193%)*
Ultimate	2375	4563 (193%)
		(360° lining)
First Crack	--	4250
.01" Crack	2188	4750 (217%)
Ultimate	2313	5250 (227%)

Two 8 foot sections of 24" ID, corroded, single steel ring reinforced concrete pipe were cut into four 4 foot sections; one 4 foot section from each 8 foot section was lined with the Danby system. The other 4 foot section from each of the 8 foot sections was tested as the control for the corresponding lined section. The new wall thickness was 3" and the wall thickness lost to corrosion averaged about 1.25" in the top half of the pipe, with maximum loss at the springlines. There was evidence that the steel cage had begun corroding and was exposed in spots. The Danby system was used to line two of these 4 foot sections; one with lining covering approximately 270° of the interior wall, leaving the 90° in the invert of the pipe unlined and resulting in an internal diameter of 23". The other Danby liner covered the entire inside of the host pipe and had an internal diameter of 20.75". The D-Load figures given above were calculated by dividing the total load on the pipe by 8 (= length x diameter of test pipe).
