# NEWSLETTER 2018

Danby used in Cast-in-Place Manholes after Harvey

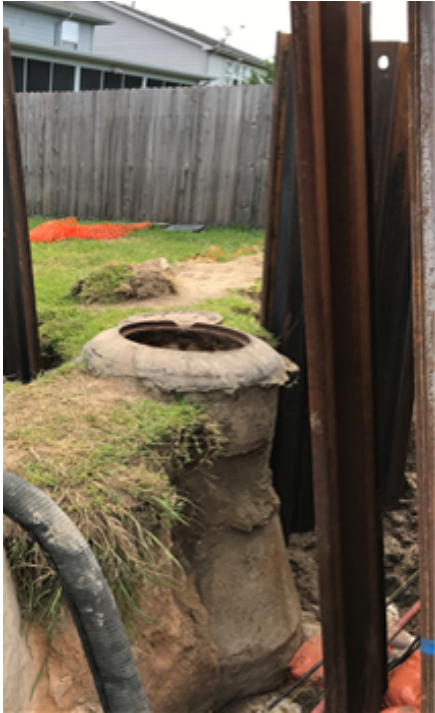
*Floodwaters eroded soil*

When the contractor arrived at this sanitary manhole, the earth around the manhole was washed away by floodwaters into an adjacent drainage canal creating a sinkhole. The Operator of the District's water system set sheet piling in an attempt to stop the erosion. The bottom of the manhole was ruptured causing flood water to pour into the sanitary sewer system.

As the flood waters from Hurricane Harvey left its mark on the City of Houston's Infrastructure, issues became obvious once the flood water started receding. Sink holes were rearing their ugly heads as further findings of failed manholes due to age, H<sub>2</sub>S corrosion and increased pressures from the floodwaters.

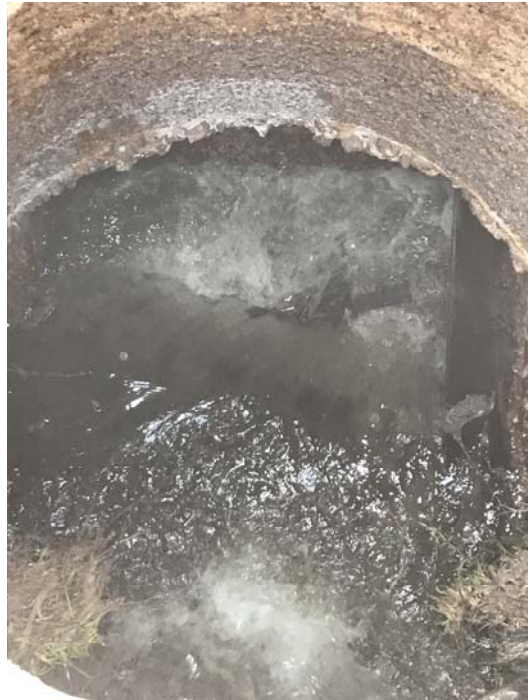
*Breach in bottom of manhole*

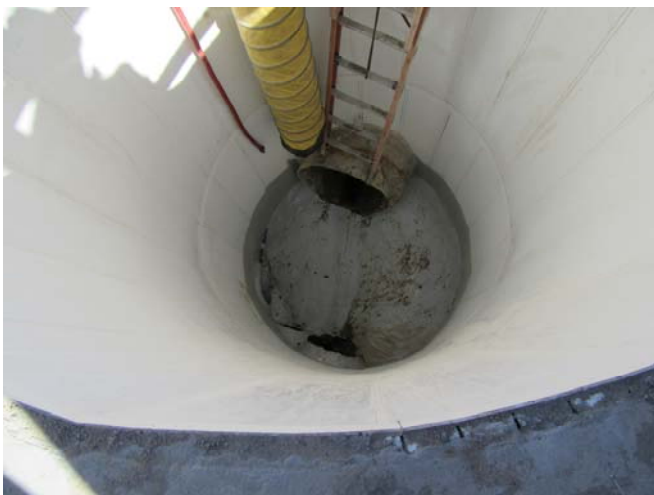
This manhole was a cast-in-place Danby lined manhole with 2 layers of rebar and 1' thick concrete walls. The contractor confirmed a 10", 12" and an 18" downstream lines were all live and tied them back into the new manhole. An 8x8 manhole lid was cast on-site. The lid was also made with the underside lined with Danby PV liner providing corrosion protection.

**Finished Manhole**

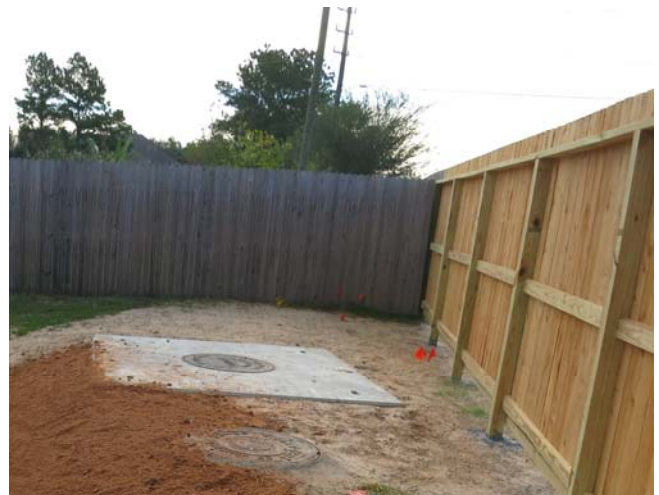
**Manhole Complete**
