Presented At
The ASCE Materials Engineering Conference On Infrastructure: New Materials And
Methods For Repair
San Diego, California
November 13-16, 1994

Structural Characteristics of the Danby Pipe Renovation System

This paper describes a pipe renovation system and its structural characteristics which results in a PVC liner mechanically bonded to injected cementitious grout which in turn bonds to the inner wall of the host pipe.

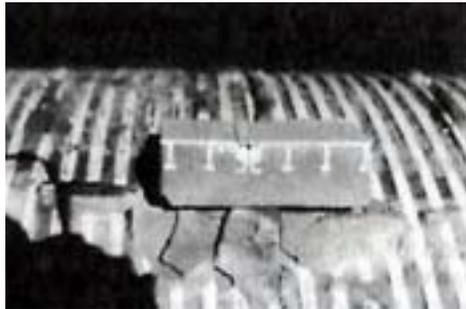
Figure 1. PVC/Grout Sample Figure 2. Core Sample of Lined RCP

The Danby Pipe Renovation System produces a PVC liner mechanically bonded to the host structure by cementitious grout. Grouting of the annulus between the liner and the old pipe is an important (and integral) part of the Danby process in all applications. Annulus grouting not only provides important structural properties (the main topic of this paper), but also may produce some level of repair to the old pipe by filling cracks and voids. Figure 1 shows a sample of the PVC and grout while Figure 2 shows a core sample taken from a 54" RCP with PVC and grout.

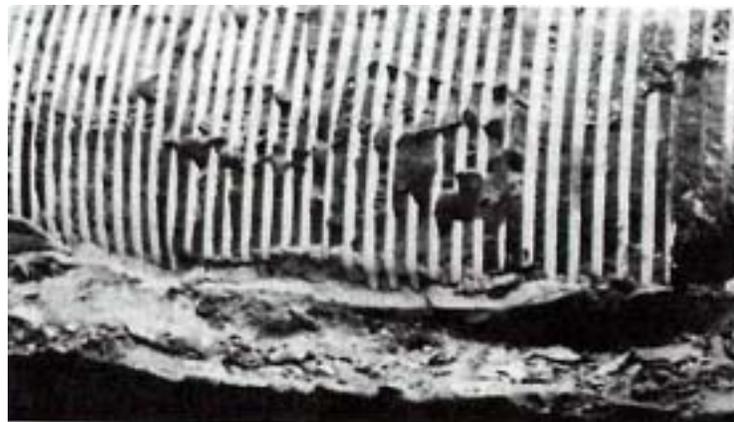
After the test was completed, a postmortem was performed by uncovering the pipe and prying the quarter sections of the broken pipe away from the liner (see Figure 4). The visual evidence clearly showed that the grout had sheared along the top of the PVC profile T's but otherwise remained, for the most part, intact in two parts; one part, that between the top of the T's and the pipe wall, still firmly bonded to the pipe wall and the second part still within the PVC profile, between the T's. Further, close inspection revealed little cracking of the grout which remained within the profile except along the hinge line at the sides of the pipe (roughly at 3 and 9 o'clock). Although this shearing action could not be visually observed during the test, it was distinctly heard as loud "popping" noise as the lined pipe started to deflect. Obviously, this noise also accompanied the cracking of the grout bonded to the host pipe along longitudinal lines at the top and bottom, and possibly the sides, as the entire structure began deflecting as 4 rigid quarter sections hinged together at the sides. It is significant that the grout between the T's in the PVC profile remained intact and largely uncracked after almost 20% deflection. Further it is significant that this PVC/grout structure clearly added significant load carrying capacity as it deflected.

Figure 4. Postmortem After Utah Soil Cell Test
