**UNDERGROUND CONSTRUCTION TECHNOLOGY
INTERNATIONAL CONFERENCE & EXHIBITION
JANUARY 19-21, 2010
TAMPA, FLORIDA**

REHAB OF 100 YEAR OLD BRICK STORM SEWER

Authors: Datta Shirodkar, P.E. – Project Manager– Boyer Inc.
Michael Spero, P.E. – President - Danby LLC

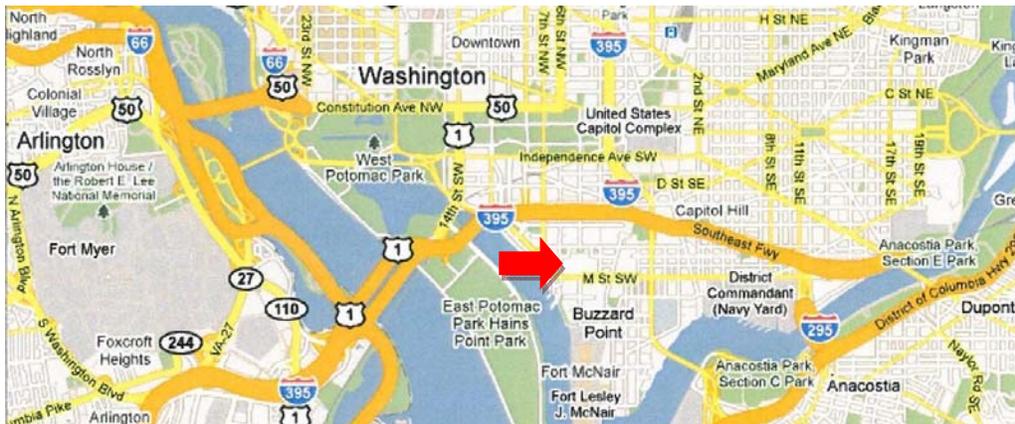
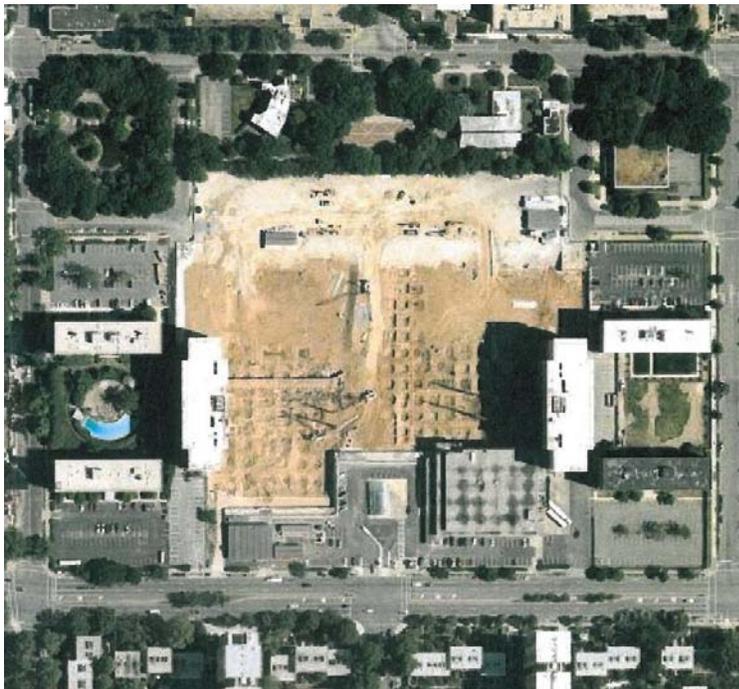
Site

The project site is at K Street & 4th Street SW a little less than a mile southwest of the Capitol.

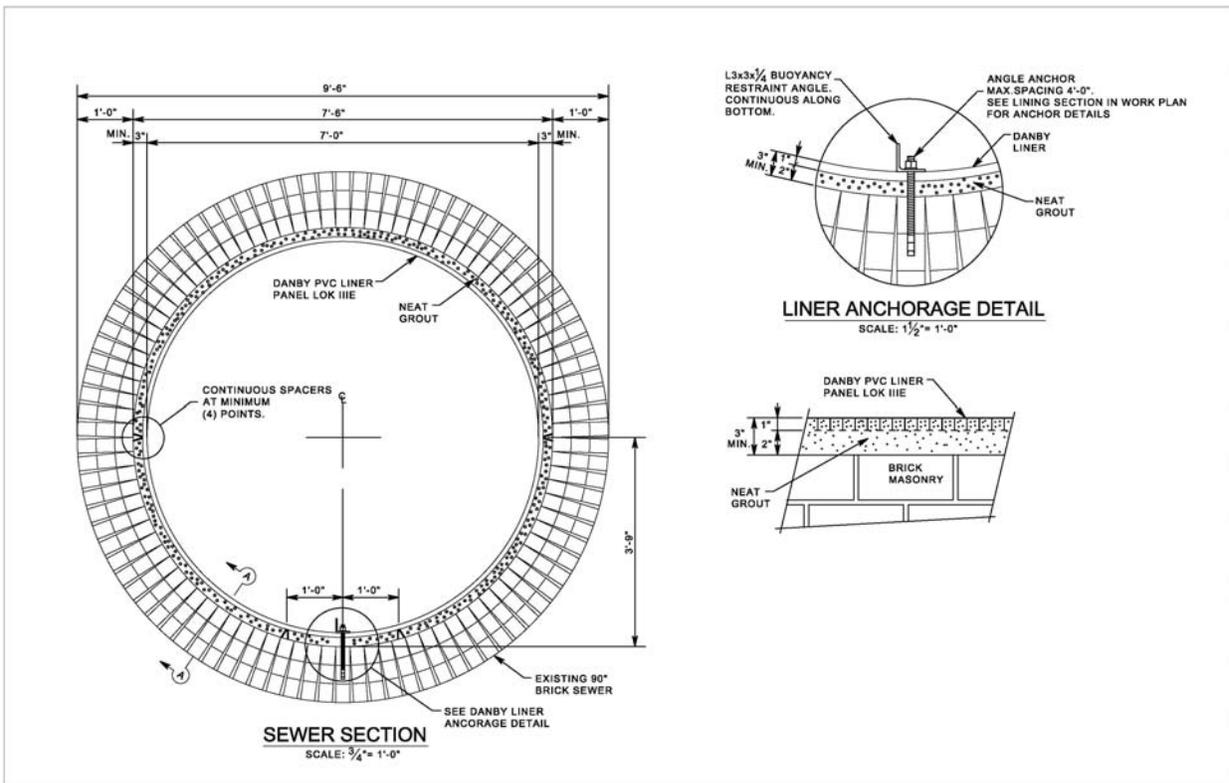
As can be seen in the drawings below the 3-inches of grout in the annular space will result in a liner ID of 84-inches. In order to maintain the 3 inch minimum grout thickness, steel spacers (bolsters) are mounted on the pipe wall. The 12-inch wide PVC panels come in 300 foot long coils. The liner is fed into the pipe through the manhole then pulled into position. The panels are spiral wound by connecting the adjacent panels with a Joiner Strip. The Joiner Strip is installed using a pneumatic Palm Hammer. The end of the next coil is connected to the previous one with an "H" Strip splice. A steel buoyancy restraint angle is anchored at the bottom of the liner. Grout bulkheads are placed about every 400 feet using hydraulic cement.
