Underground Technology Cutting Edge Technical Information For Utility Construction & Rehabilitation

## Rehab Of A 100-Year Old Brick Storm Sewer

by Datta Shirodkar, Boyer Inc. and Michael Spero, P.E., Danby LLC

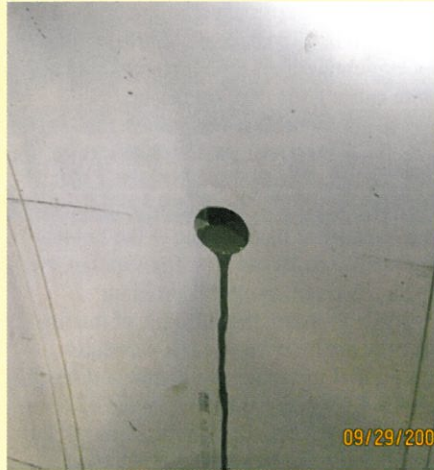
As can be seen in the drawings, the three-inches of grout in the annular space will result in a liner ID of 84-inches. In order to maintain the three-inch minimum grout thickness, steel spacers (bolsters) were mounted on the pipe wall. The liner is fed

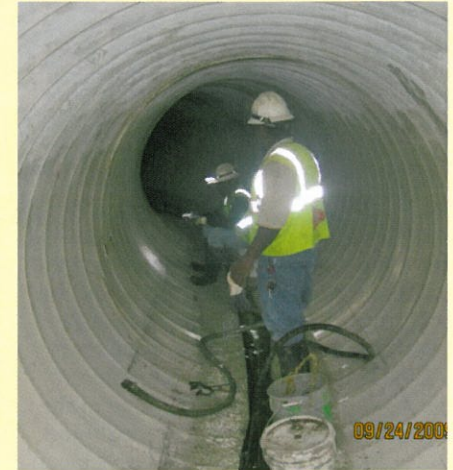
The PVC liner panels, besides being water-tight and corrosion-resistant, are essentially the "form" for the high-strength grout. It is the cementitious grout that provides the structural rehabilitation of the pipe. The current state of stress of the existing pipe was determined through a finite element analysis and the minimum grout thickness was calculated using the Flexural Stress Cracking Design Method (Composite

Material Design). The grout consists of Portland cement (57 percent), Fly Ash (43 percent), and water and super-plasticizer admixture. Although the design is based on a grout compressive strength of 6,000 psi, typically the tested 28-day strength is 7,000 – 9,000 psi. The grout will normally set-up in four to 5 hours (firm to the touch) and develop a compressive strength of more than 1,000 psi in 24 hours.
